Cannondale Motorsports Service Bulletin

BULLETIN : SB02-003

MODELS : MC1000 Update Kit - ATV, P/N 913-6000712

SUBJECT : Correction to kit instructions

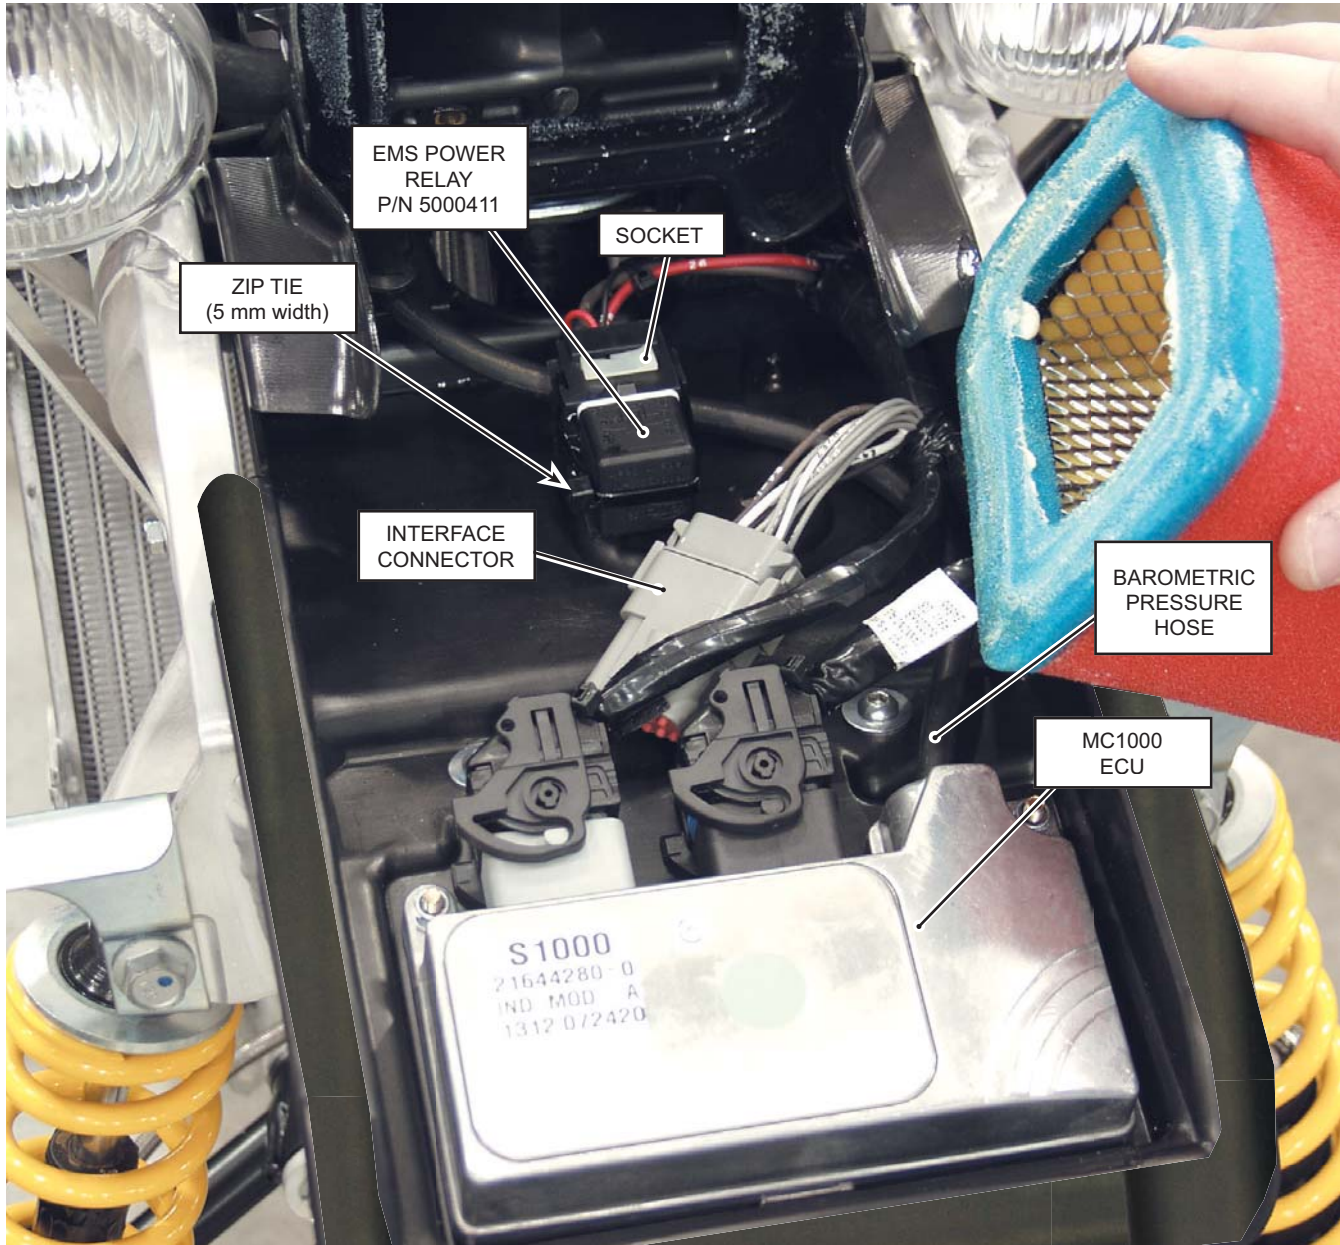
RELAY INSTALLATION (MC1000)

CONDITION : A required step was not included in the installation instructions for MC1000 Engine Management System updates kits for ATVs, P/N 913-6000712, shipped prior to 3/6/02 . The document titled "MC1000 Update Kit - ATV" (6000712-I), did not include the step for removing one of the two relays of the MC500 wiring harness and inserting it into the single socket on the MC1000 harness included with the kit. Either relay of the MC500 system (EMS power or fuel pump) can be used in the MC1000 system if the relay is un-damaged and functioning properly. The location of the relay on the vehicle electronics tray can be seen in the photo on page 2.

If the EMS power relay is not installed as indicated, the engine will start and run, but damage to a diode incorporated in the vehicle wiring harness can result. When this happens, the engine will not start or may shut off during operation.

Remove one of the two relays of the MC500 wiring harness. Test the relay for proper operation. Apply some dielectric grease to the relay terminals and insert the relay into the MC1000 harness socket. Secure the relay to the socket using a plastic zip tie. The tie used should have a minimum width of 5 mm (See TB02-001). Be sure not to pinch or bind any of the wires entering the back of the socket when installing the tie. See photo on page 2.

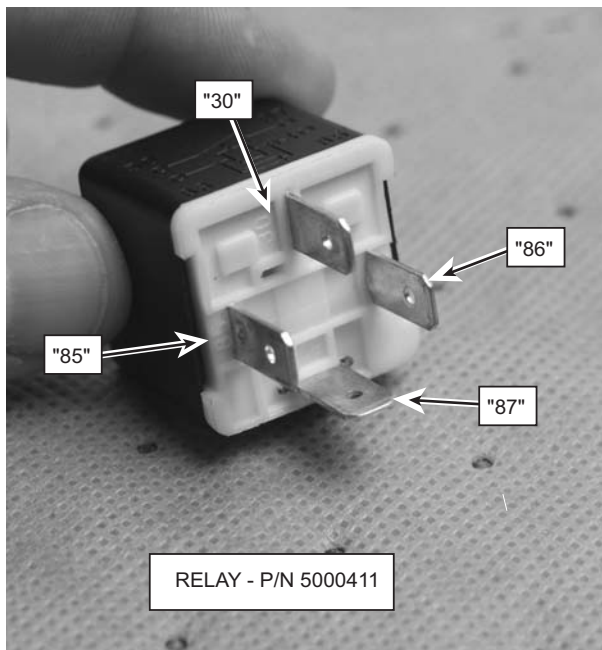
There are no markings on the socket itself; use the illustration below for identification.

1. Remove the relay from its harness socket.
2. Using an ohmmeter, connect the positive probe (+) onto terminal number 86 and the negative (-) probe onto terminal number 85 and check the resistance. The resistance should be 73 ohms (+/- 10%). If the resistance is out of specification → replace the relay with a new one.
