Technical Publications

SERVICE BULLETIN

Bulletin Number	Issue date	Model(s) Affected	Subject
SBM00002	8/7/00	2001 MX400 - up to and including VIN 5B6AA11C21B000034	transmission mainshaft circlip groove inspection

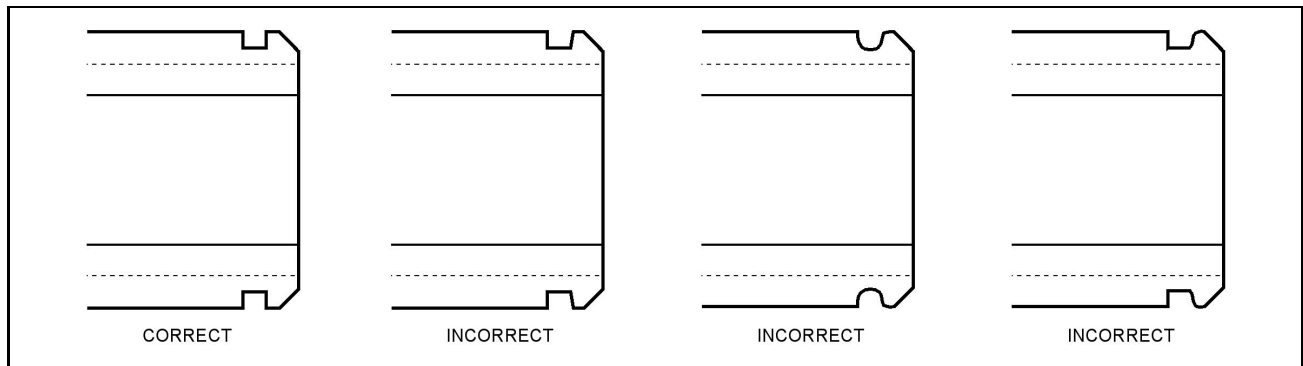
- 2 Remove the shift lever bolt and remove the shift lever.
- 3 Remove the clutch cover.
- 4 Remove the six bolts, washers, and springs securing the clutch pressure plate. Loosen the bolts in stages in a criss-cross pattern.
- 5 Remove the pressure plate.
- 6 Remove the clutch plates.
- 7 Remove the circlip retaining the clutch hub.
- 8 Inspect the circlip groove with a minimum 10x magnifying lens for the conditions illustrated. Holding a white piece of paper opposite the side of the groove being inspected will improve the contrast.

- 9 Inspect each spline individually as the condition of the groove may vary between splines. If more than 5 splines in total or 3 in a row exhibit an incorrect condition, the shaft must be replaced. Please call Cannondale Dealer Service at (877) 357-6686 for the procedure. If the circlip groove is correct install the new circlip supplied with the rounded edge of the circlip toward the clutch hub.

The circlip must be installed with the rounded edge of the circlip facing the clutch hub. If installed in the opposite direction the circlip can be pushed off of the shaft by the clutch hub and allow the hub to move outward on the shaft. When this occurs, the clutch cannot be disengaged and may cause the rider to lose control of the motorcycle.
