Cannondale Motorsports Service Bulletin

BULLETIN : SB02-002

SUBJECT : Coolant pump impeller

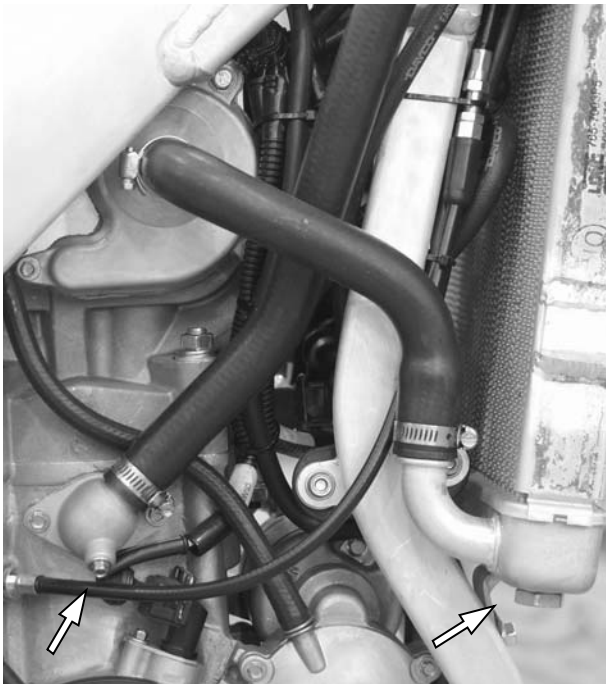
1. Remove the radiator drain bolt at the bottom of the radiator and allow coolant to drain into a suitable container. Check the O-ring on the drain bolt; apply some O-ring lubricant and reinstall the bolt. Tighten the drain bolt securely.

Remove the outlet cover drain bolt and sealing washer, and allow the coolant to drain completely.

Check the condition of the sealing washer and reinstall the sealing washer and drain bolt. Tighten the drain bolt to 3.3 lbf•ft (4.5 N•m).

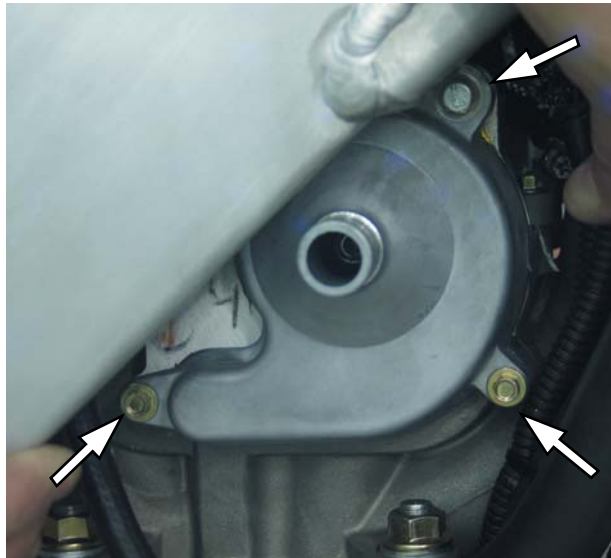
3. There are four bolts securing the coolant pump cover. Remove the three coolant pump cover bolts indicated in the photo first. Be sure to note the sealing washer of the bleed bolt.

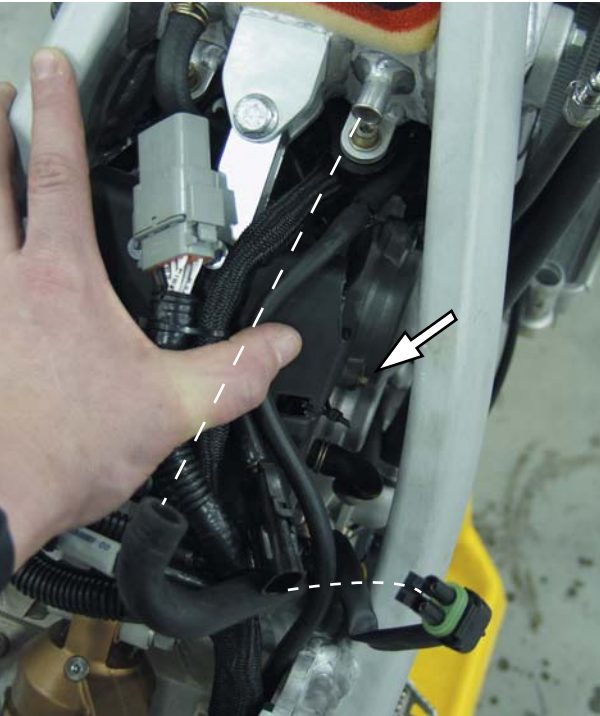
5. Remove the engine oil outlet (from scavenge pump) clamp and hose and move the hose out of the way. Disconnect the stator lead from the harness connection and move it out of the way.

Remove the fourth cover bolt. Use a small 6mm box-end wrench.

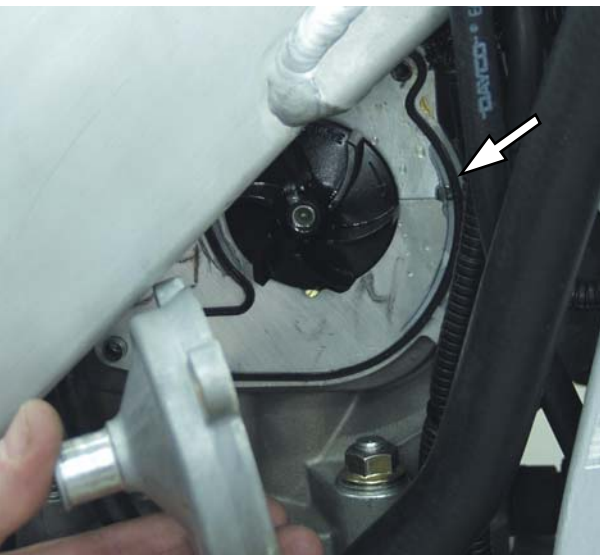
- Carefully work the cover straight off. Do not use sharp instruments to pry at the cover edges; damage to the mating surfaces will result. When the cover is off, check the condition of the cover seal. If it is damaged, replace it with a new one. Carefully remove any old sealant from the seal. Also, check for the two small hollow locating dowels mounted in the cylinder head. These can come off with the cover and reinsert them into the two lower holes of the cylinder head.

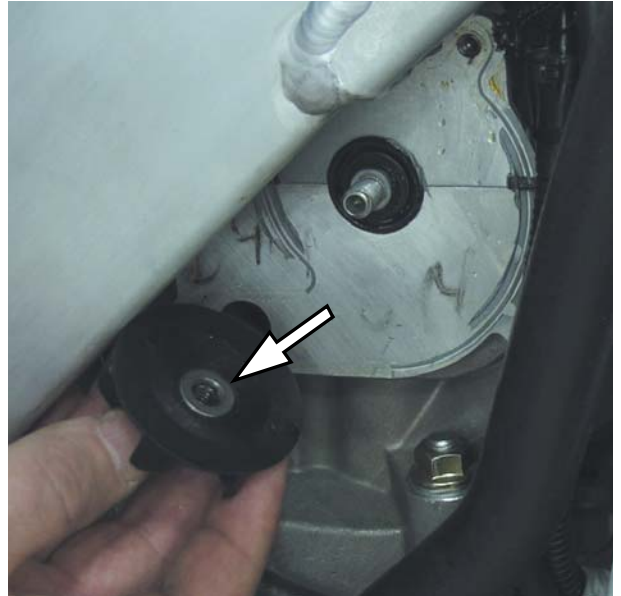
- Turn the impeller clockwise with your hand and remove it. Be sure to note the stainless steel washer behind the impeller. Remove it and save it. It must be reinstalled with the new impeller.

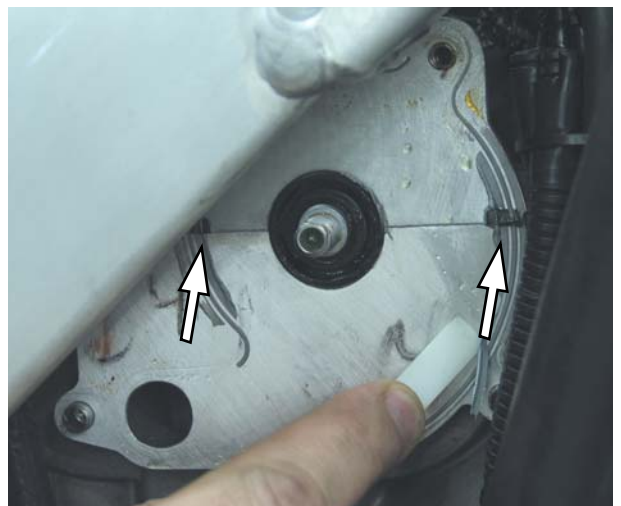
- Carefully remove any old sealant. Do not use metal instruments to scrap off the sealant; damage to the mating surfaces will result. The end of a large plastic zip tie with a fashioned tip (squared off or chiseled end) works well. Inspect the mating surfaces of the camshaft cover and cylinder head for any corrosion or damage. Take corrective action if necessary.

Work very carefully when removing old sealant. Do not damage the two small camshaft cover seal ends.

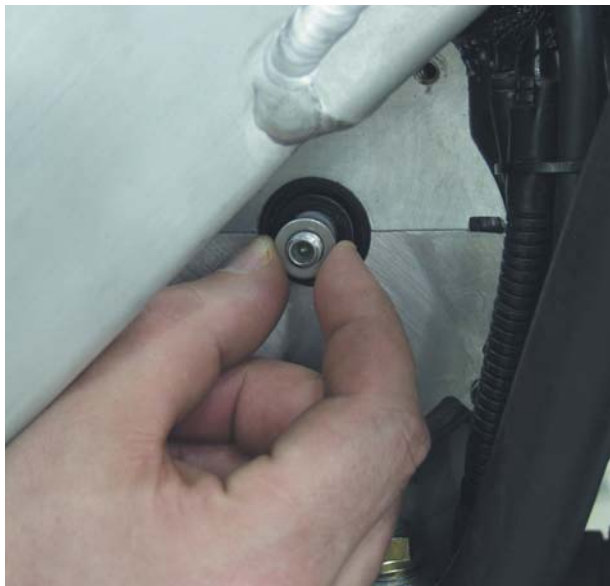
9. When all the old sealant is removed, wipe the area dry with a clean shop towel.
10. Install the stainless steel washer into the intake camshaft end.

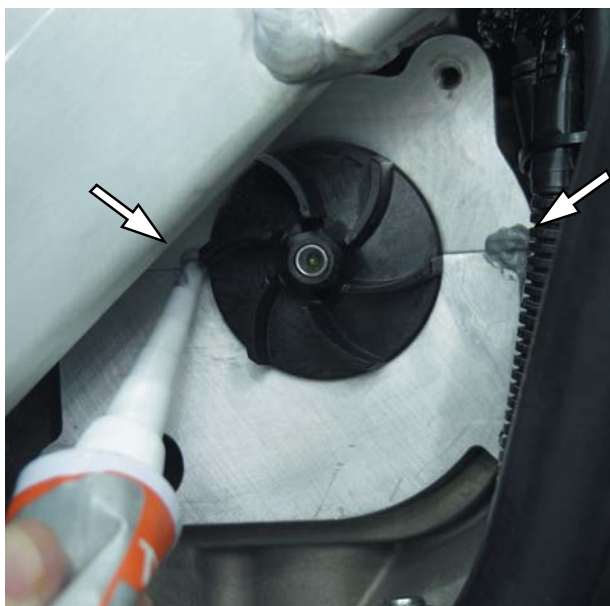
11. To install the new impeller, turn it counter-clockwise with your hand until securely tightened.
12. Apply some silicone sealant (Threebond 1207D) to the two camshaft cover seal ends. Only apply enough to cover the ends.

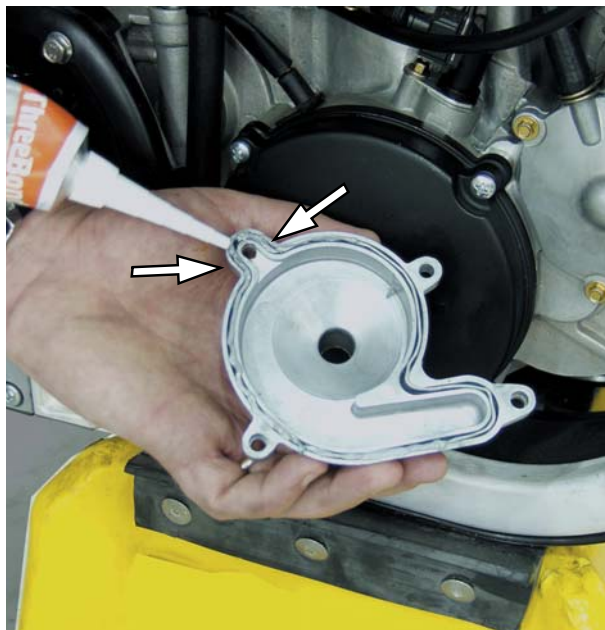
13. Wipe the cover dry with a clean shop towel, and insert the cover seal into the groove. Apply a thin bead of silicone sealant to the seal.

Do not over apply sealant. Excess sealant, especially in the area of the cover bleed bolt, can obstruct proper coolant bleeding of both the manual and self bleeding covers.
