Service Bulletin

2003 X440

Fuel System Hose Inspection

BULLETIN : SB02-013

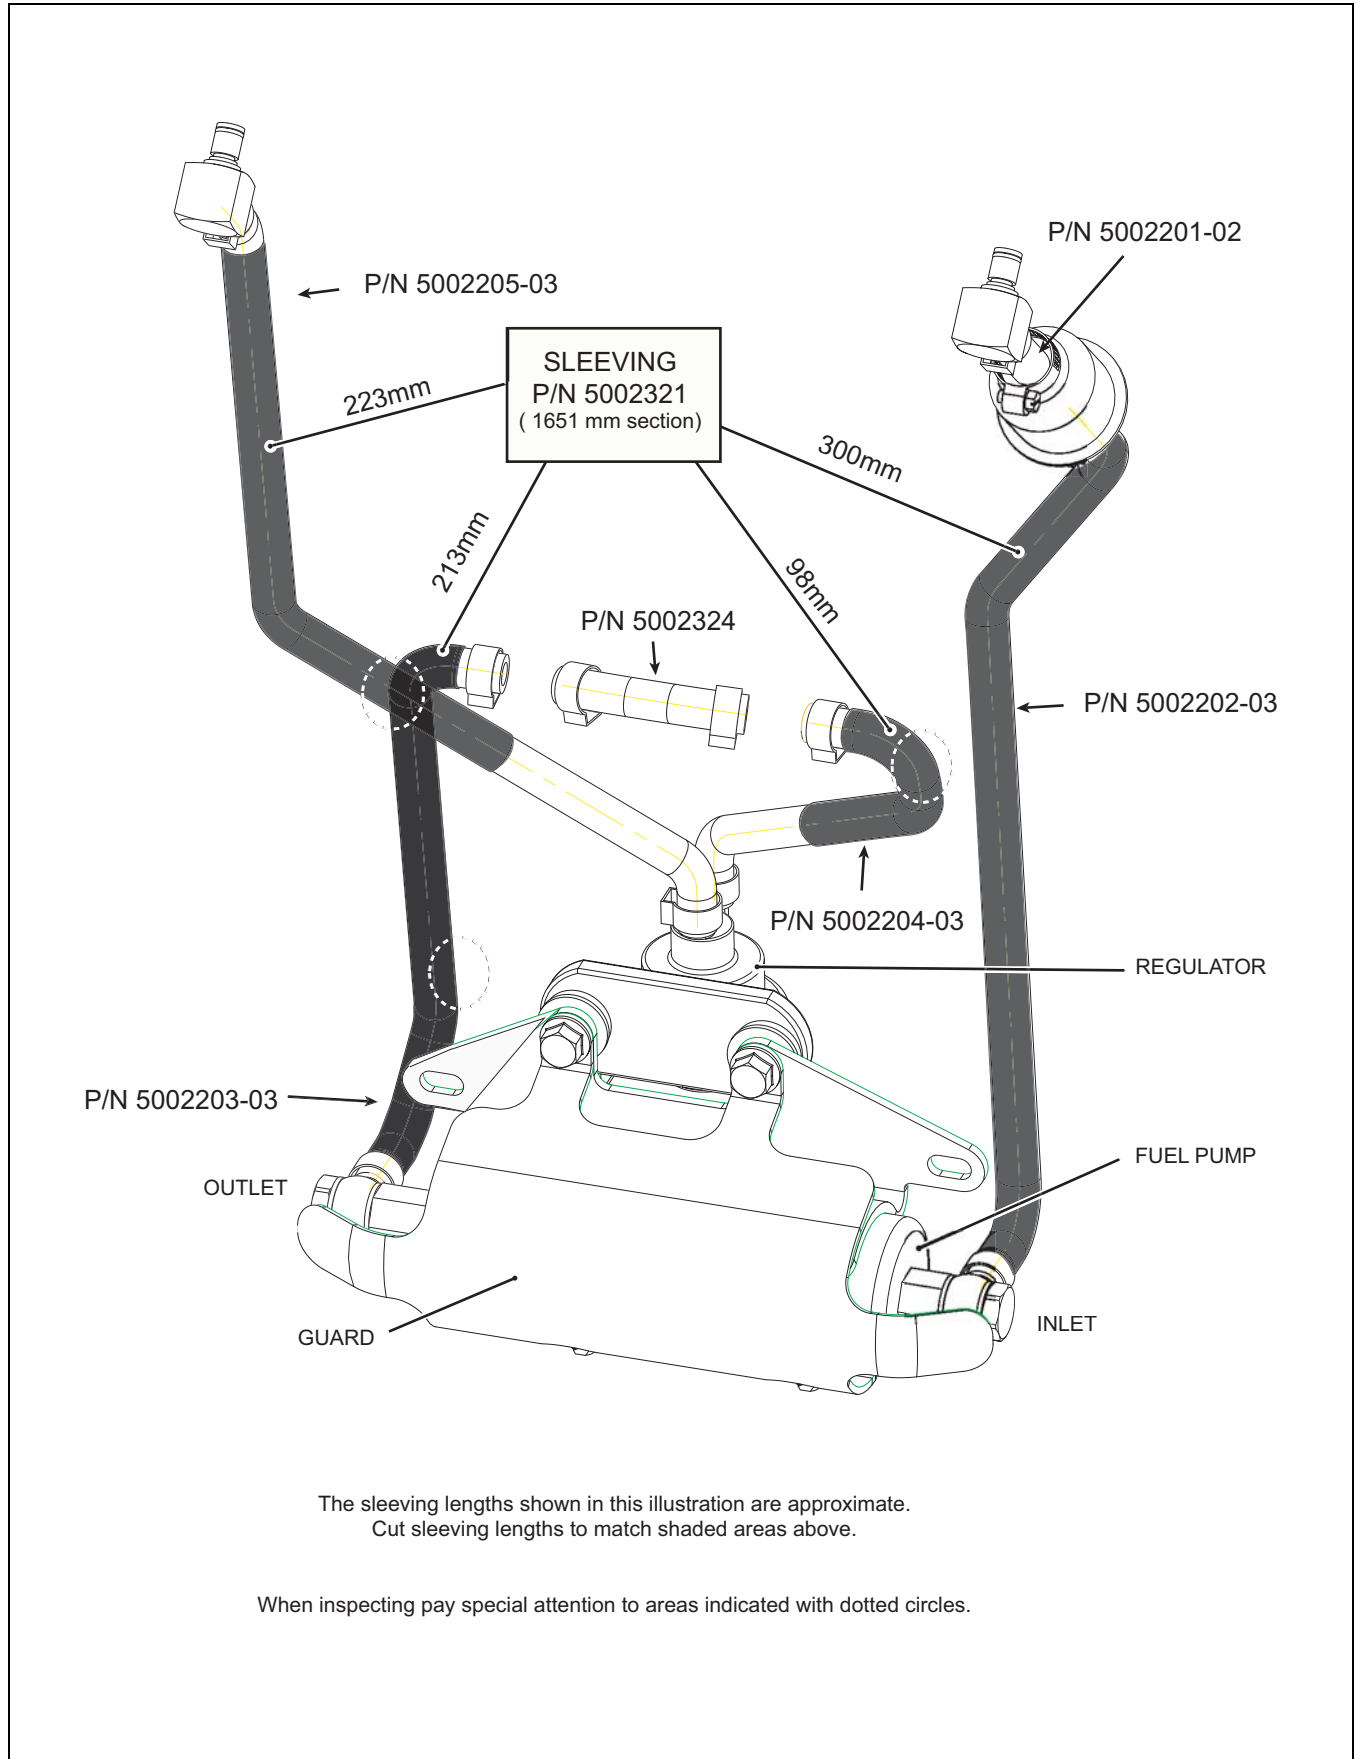
FUEL SYSTEM HOSES

1. Visually inspect all fuel system hoses to confirm that the correct lengths of sleeving have been installed.

If any hose is not covered as indicated by the following illustration, carefully inspect it for any signs of damage, abrasion, or fuel leakage. Replace any damaged hose with a new one.

Cut and install any required sleeving. Position it as indicated in the following illustration.

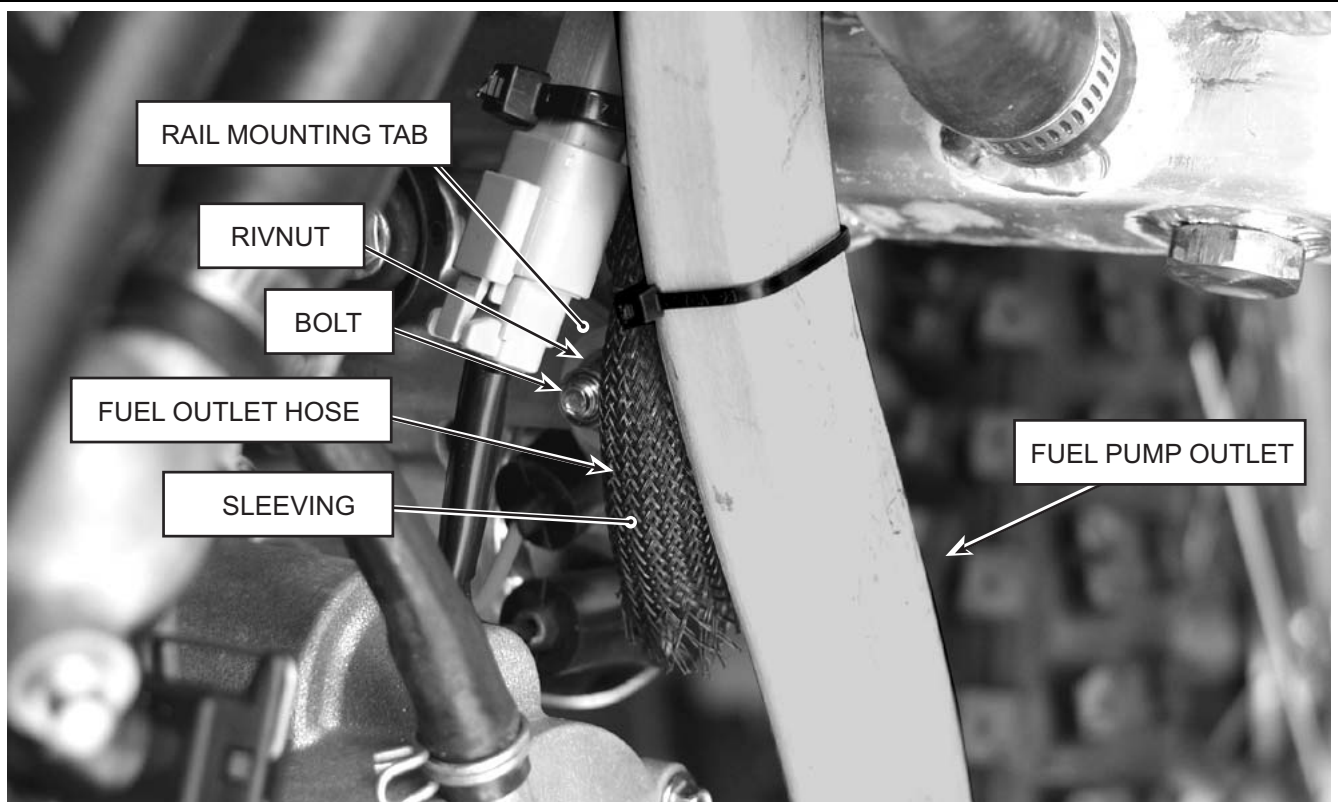
FUEL PUMP OUTLET HOSE

This photo shows the correct assembly method of the fuel pump outlet hose. Notice that the SLEEVING covers the FUEL OUTLET HOSE as it pass the BOLT end. Notice also that the ZIP TIE secures the hose and covering braid and it is positioned on the RIGHT FRAME RAIL above the MOUNTING TAB.

2. Check to make sure that the fuel pump outlet hose is secured to the right engine frame rail with a zip tie and that the tie is positioned above the fuel pump mounting tab. See "Fuel pump outlet hose" on page 4.

If the zip tie is missing, inspect the hose for damage. Check the hose closely where it passes the end of the fuel pump mounting bolt on the right engine frame rail. Prolonged contact with this bolt end can damage the hose.
