Cannondale Motorsports Technical Bulletin

BULLETIN : TB02-005

MODELS : All 2001, 2002 ATVs

SUBJECT : Air filter servicing and electronics tray seal quality

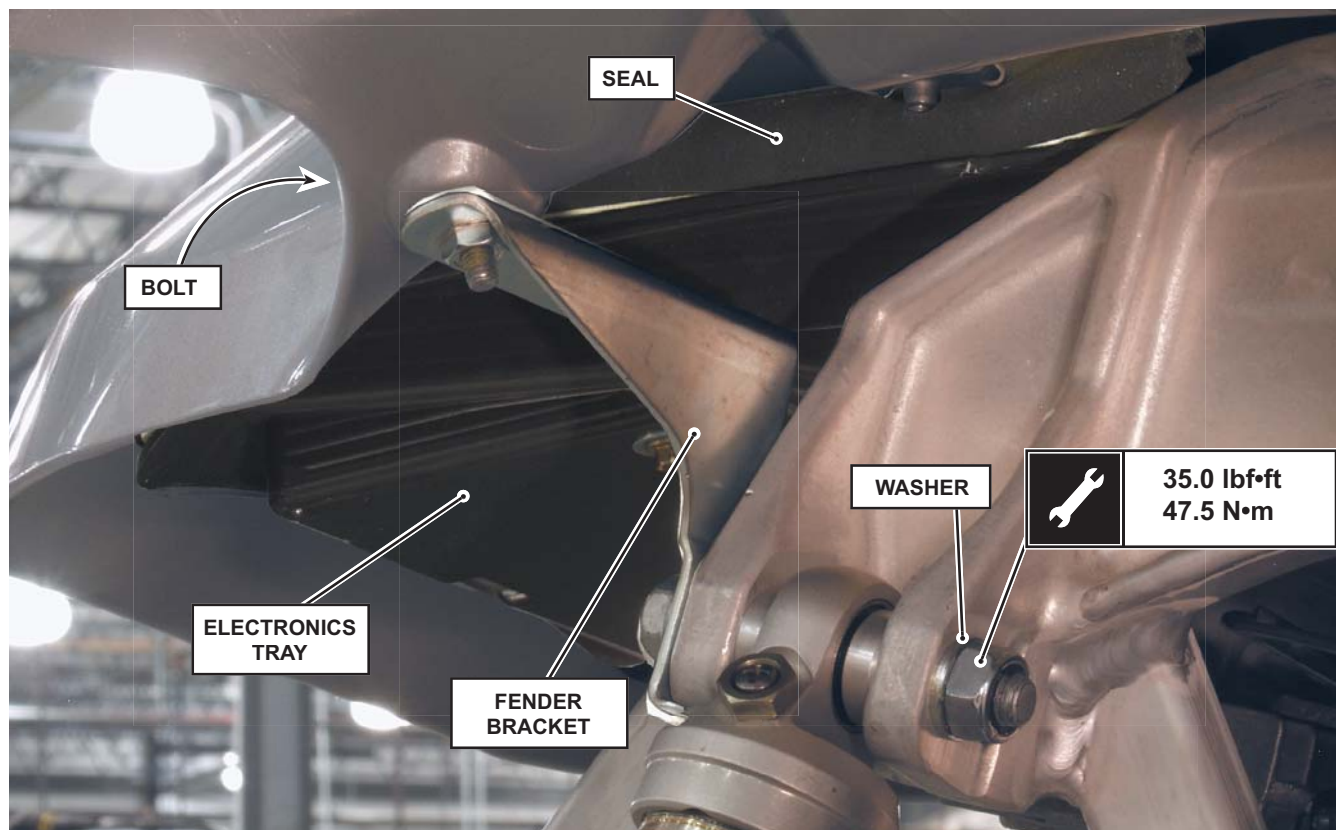
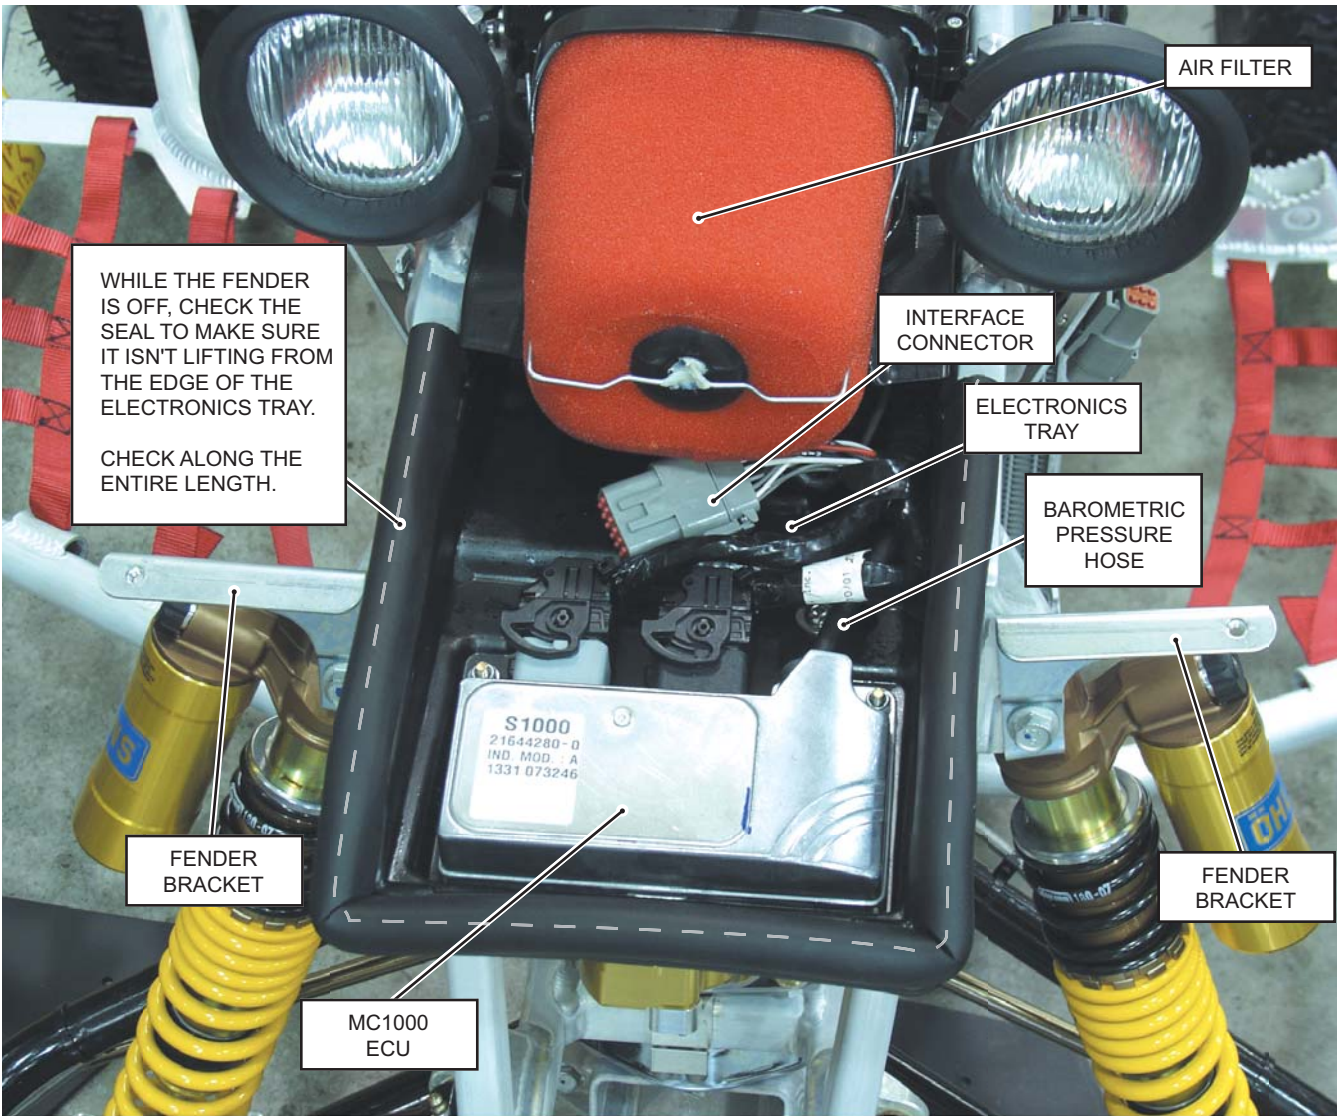
CONDITION : After servicing the air filter, inspect the quality of the seal between the reinstalled front fender (cowl) and the electronics tray. If the front fender has been damaged, the fender bracket has shifted or been bent inadvertently, or if the seal itself has been damaged, water and or other contaminants can be introduced into the electronics tray possibly damaging the components. After installing the front fender, visually check the seal quality along its entire length. Make sure there are no gaps or damage to the seal. The seal should be compressed enough to provide a positive water-tight seal. If not, it may be necessary to remove the fender mounting hardware, loosen the upper front shock bolt, and correct the bracket height to increase the pressure the installed fender exerts on the seal. When washing the vehicle, do not spray any water directly at the seal.
