## Cannondale Motorsports Service Bulletin

BULLETIN : SB02-006

MODELS : 2002 C440 up to and including VIN 5B6BC21C32B000115

SUBJECT : Incorrect routing, steering head

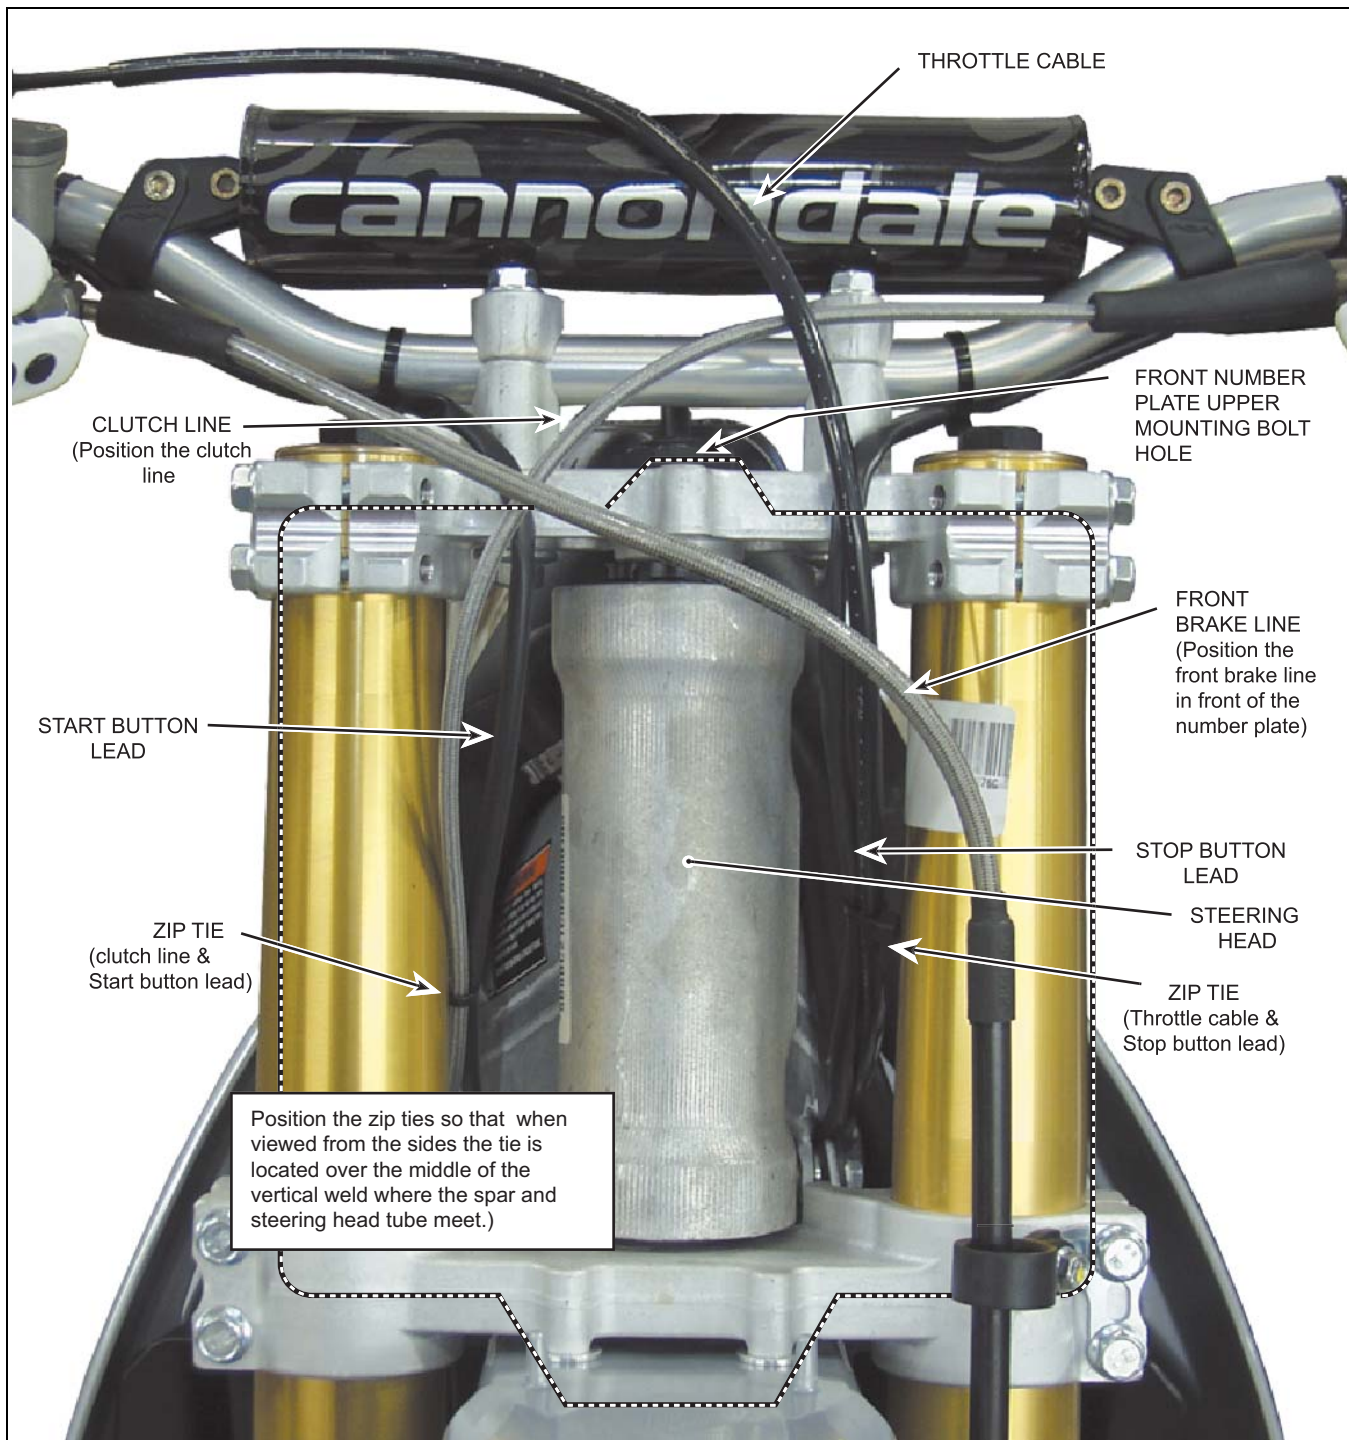
## C440 CORRECT ROUTING (STEERING HEAD)

The photo above shows the correct routing and identity of the cables and lines in the steering head area. The front number plate (represented by the dotted line ) has been removed in this photo for clarity.

*The front brake line is routed in front of the installed front number plate.*

*Notice the location of the upper front number panel mounting hole in the upper triple clamp.*

SOLUTION : Inspect that the front number plate is mounted with the throttle cable on the vehicle left side of the upper plate mounting tab and make sure the front brake line is on the vehicle right side of the mounting tab. See "C440 Correct Routing (Steering Head)" on page 2 of this service bulletin. Correct the routing if necessary. Remove the front number plate upper mounting bolt and position each cable as indicated in the illustration. If the cables were routed incorrectly, thoroughly inspect the cables and harness leads for any damage that might have occurred (e.g, bending, kinks, pinching or abrasion) and take corrective action. Reinstall the upper front number panel bolt when complete. Check the vehicle controls for proper function.
